Report of Geologic Reconnaissance

**Danube Storage Facility
12410 Lakeside Avenue
Lakeside, CA 92040
MUP 08-002, ER 08-14-001**

February 4, 2009

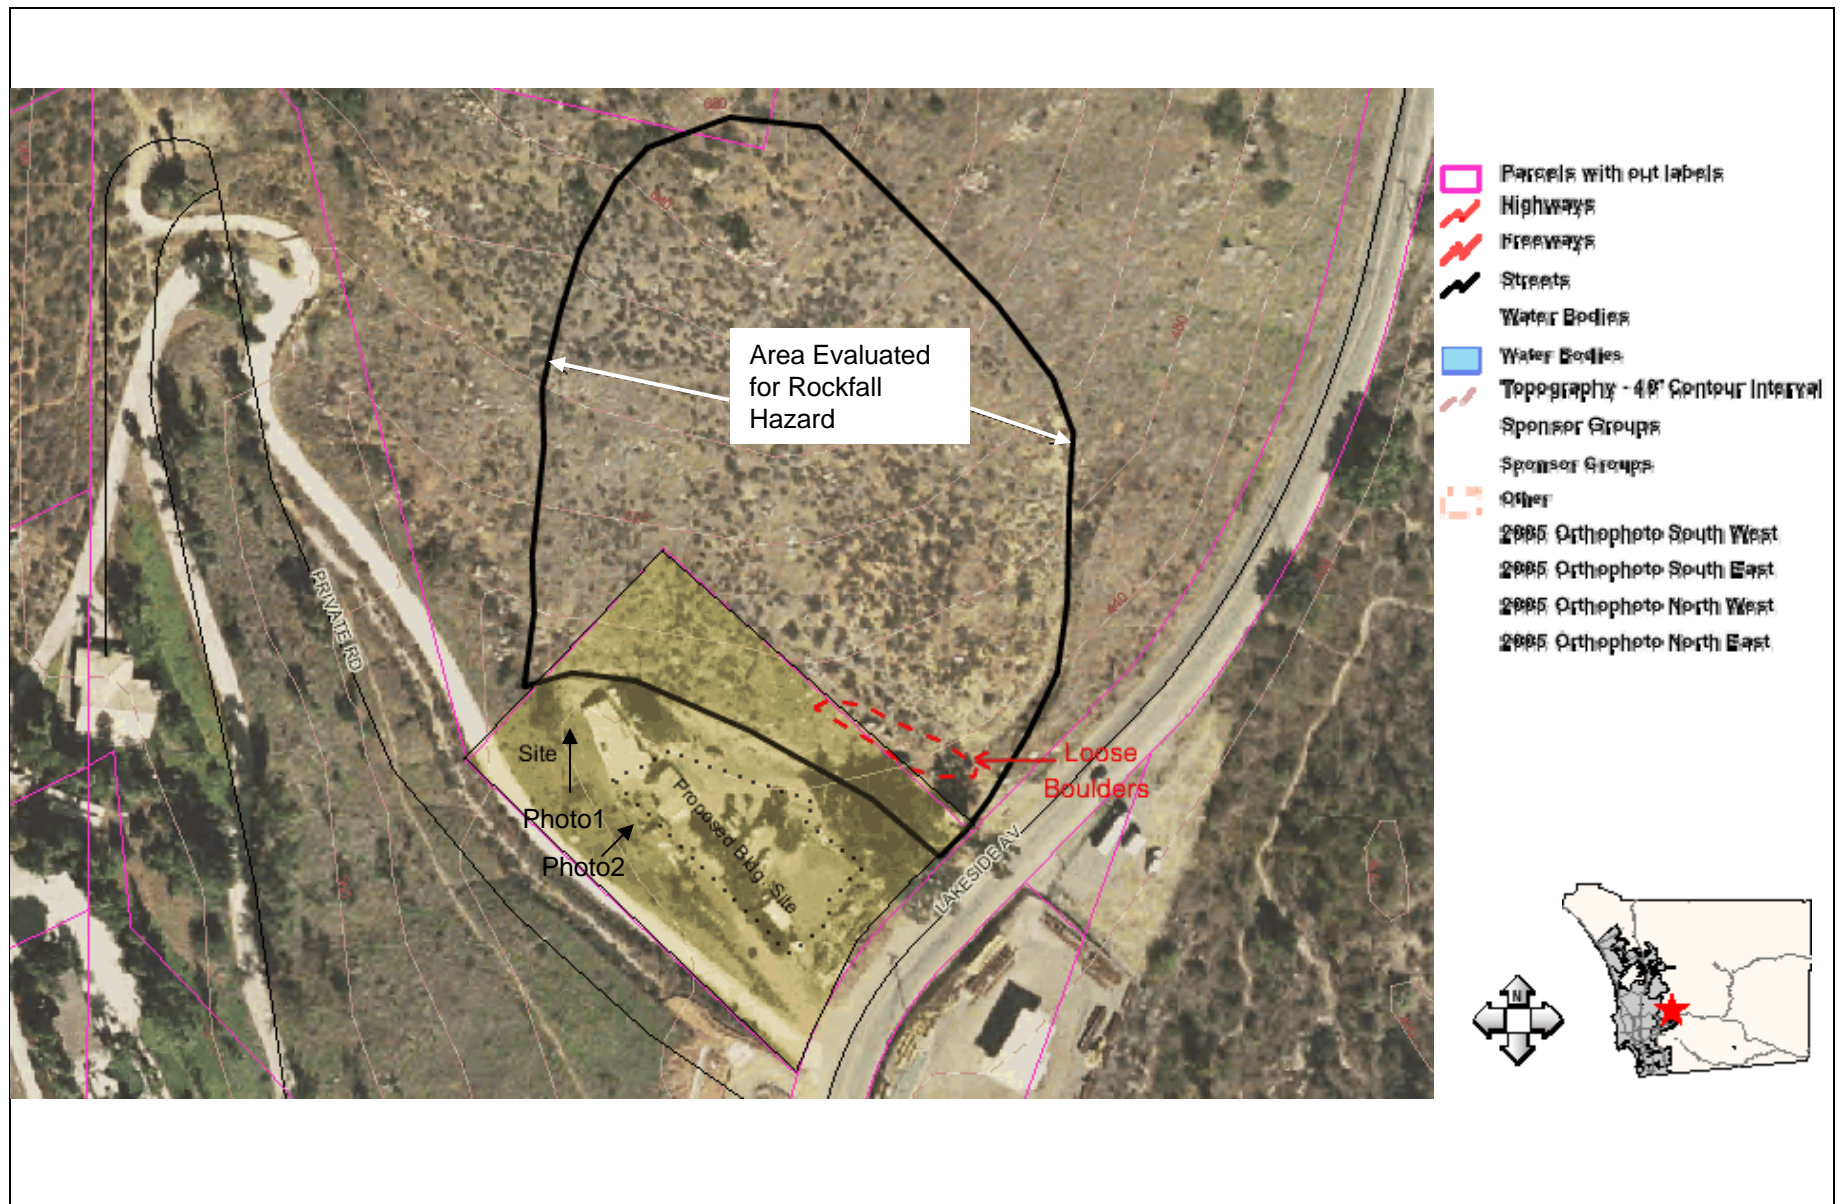
Figure 3

Area A: Evidence of a few loose rocks/boulders susceptible to falling/rolling downslope were observed during this site reconnaissance directly upslope or near the planned building pad area (Figure 3 and 4, Photograph 2). These boulders are located less than 100 feet above the planned building pad and appear to be remnant boulders from former grading activities at the site. Some of these boulders may require removal or stabilization which could be accomplished during grading of the site for development. Mitigation could be achieved by using standard grading equipment, and is feasible due to relatively easy access to susceptible boulders above the project pad area. Some of these boulders appear to be offsite on the parcel directly north of the site and may require permission from the neighboring property owner prior to removal/stabilization.

Intent: In order to avoid rockfall hazards that threaten the proposed building site, the boulders located in a hazardous position shall be removed.
